Urban Search and Rescue in San Bernardino, California, Following a Major Train Derailment in a Residential Neighborhood

**Federal Emergency Management Agency
United States Fire Administration
Office of Firefighter Health and Safety**

**Urban Search and Rescue
in San Bernardino, California, Following a Major
Train Derailment in a Residential Neighborhood
May 12, 1989**

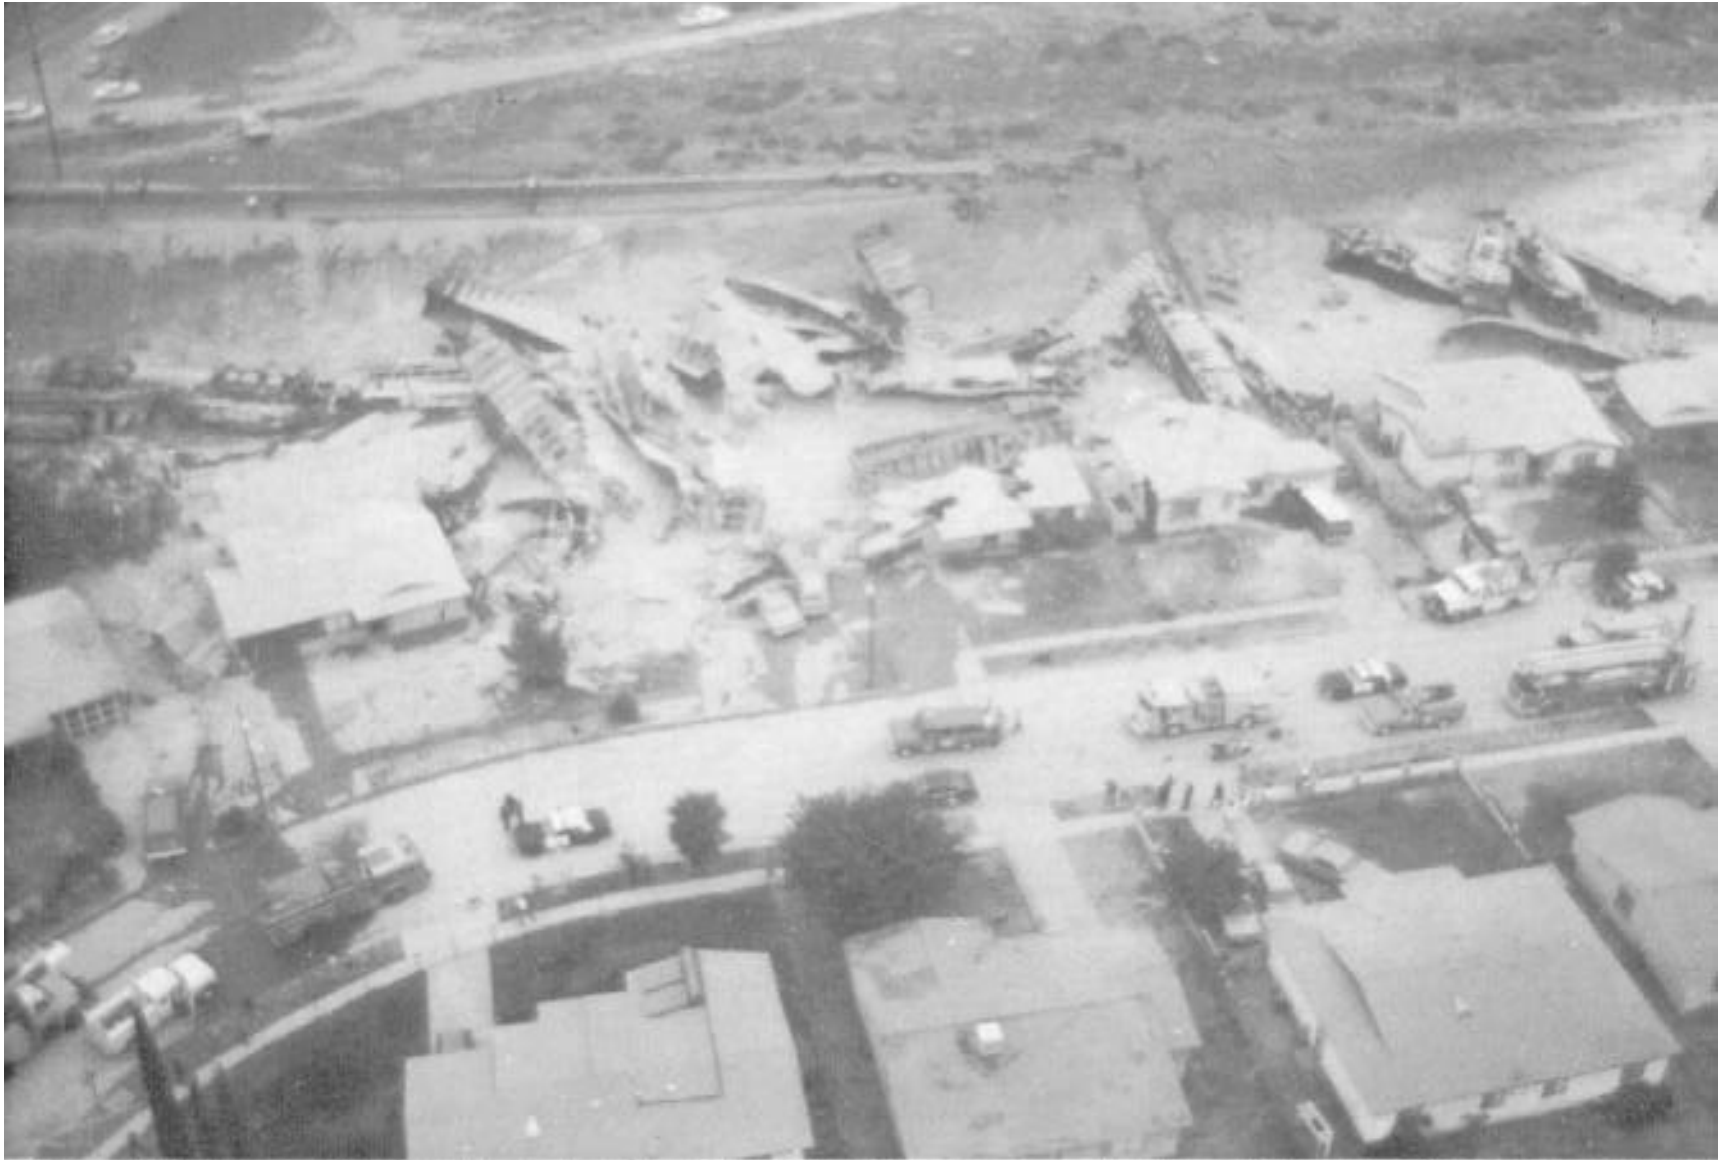
Aerial view of train derailment crash site, viewed from east to west. Duffy Street is in the foreground. Chris Shaw, buried victim, was in the debris of the house with two vehicles in the driveway in the left center of the photo.

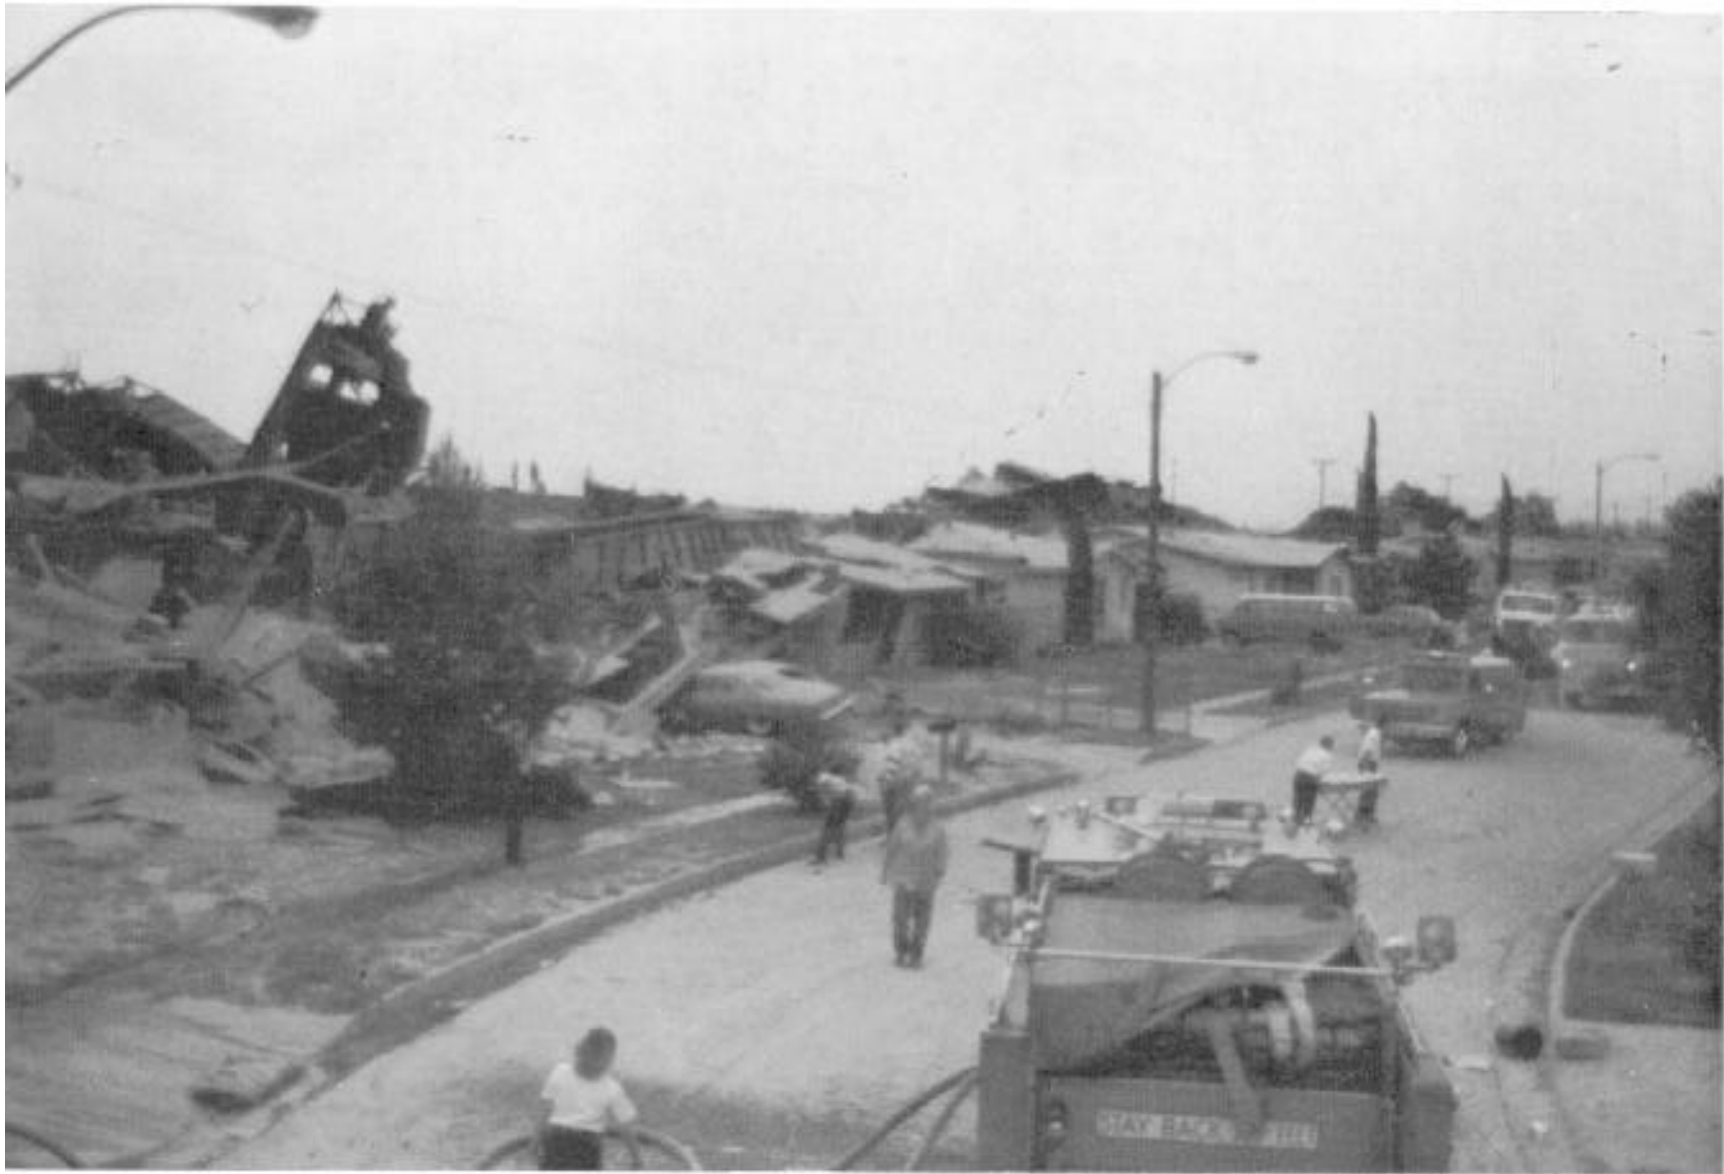
Complete destruction of houses shown, taken from Duffy Street looking north.
Victim Chris Shaw was buried below the large hopper car jutting in the air.

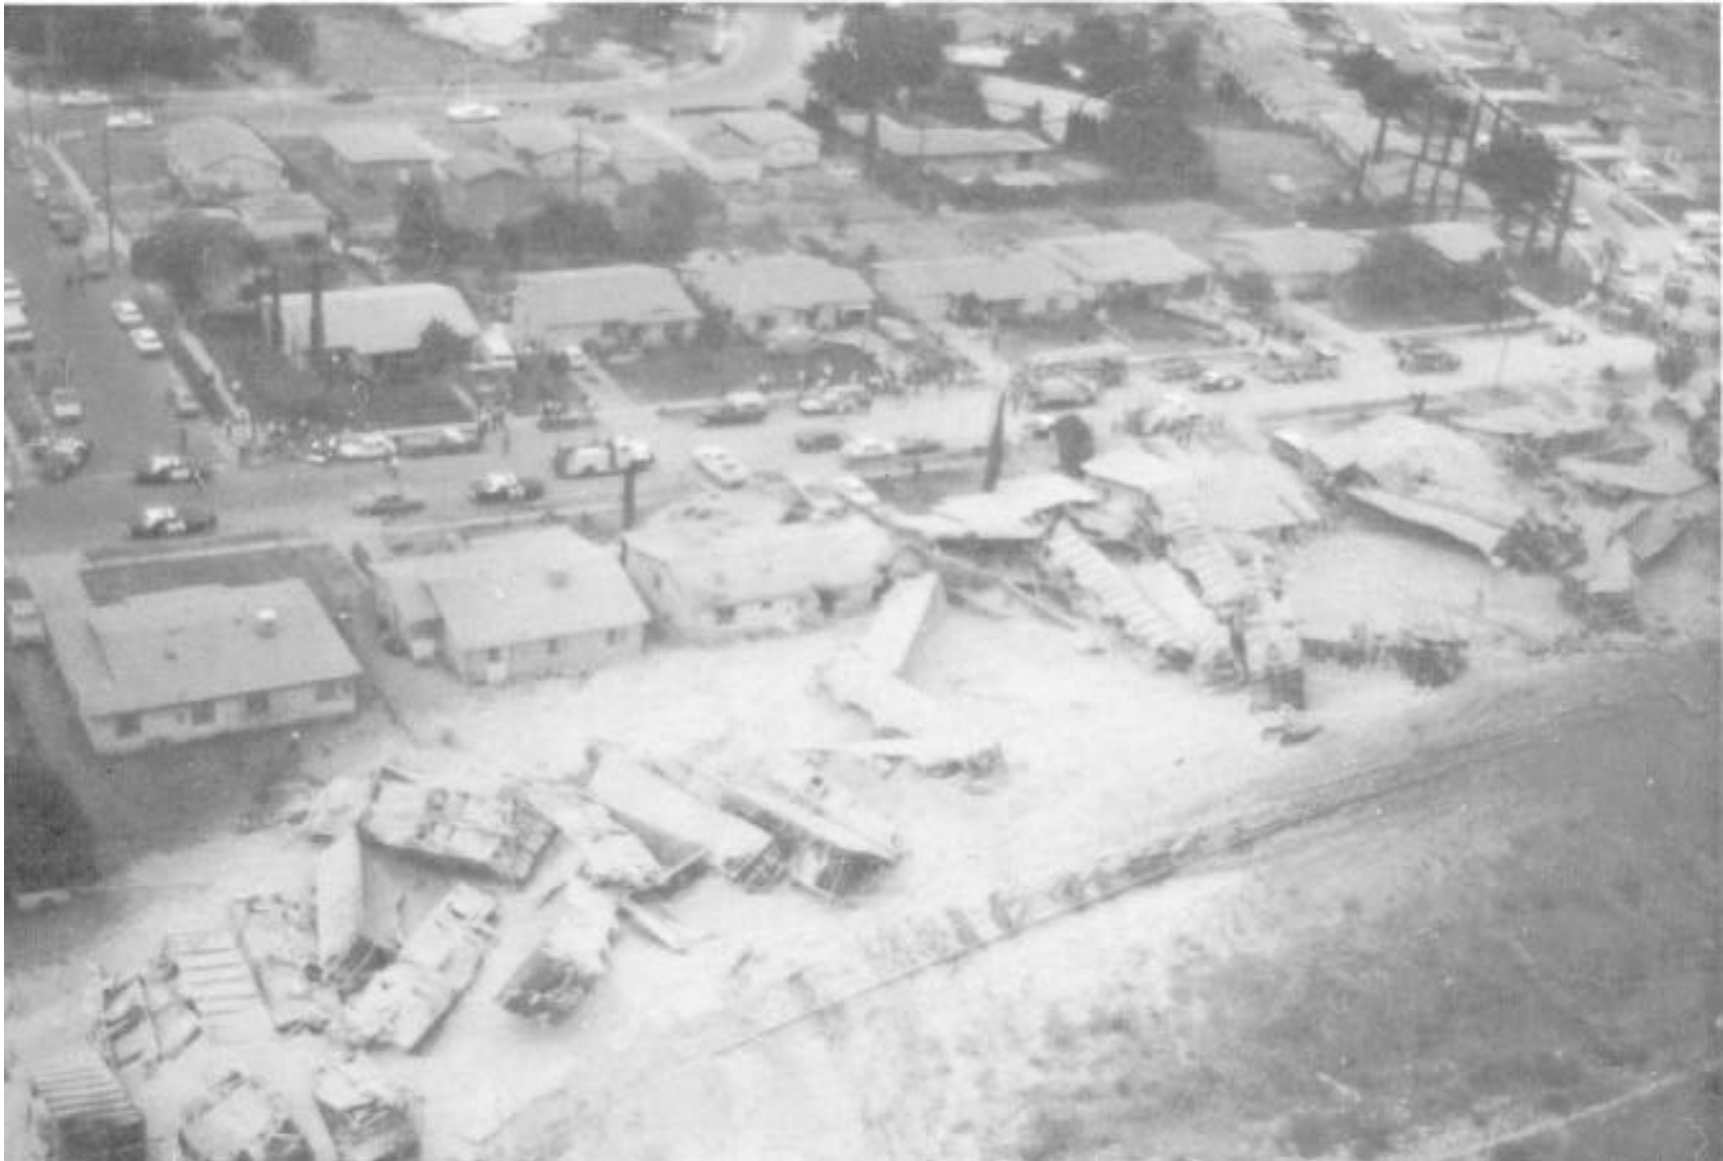
Aerial view of train derailment crash site, viewed from west to east.
The Shaw house is to the extreme right of the photo.

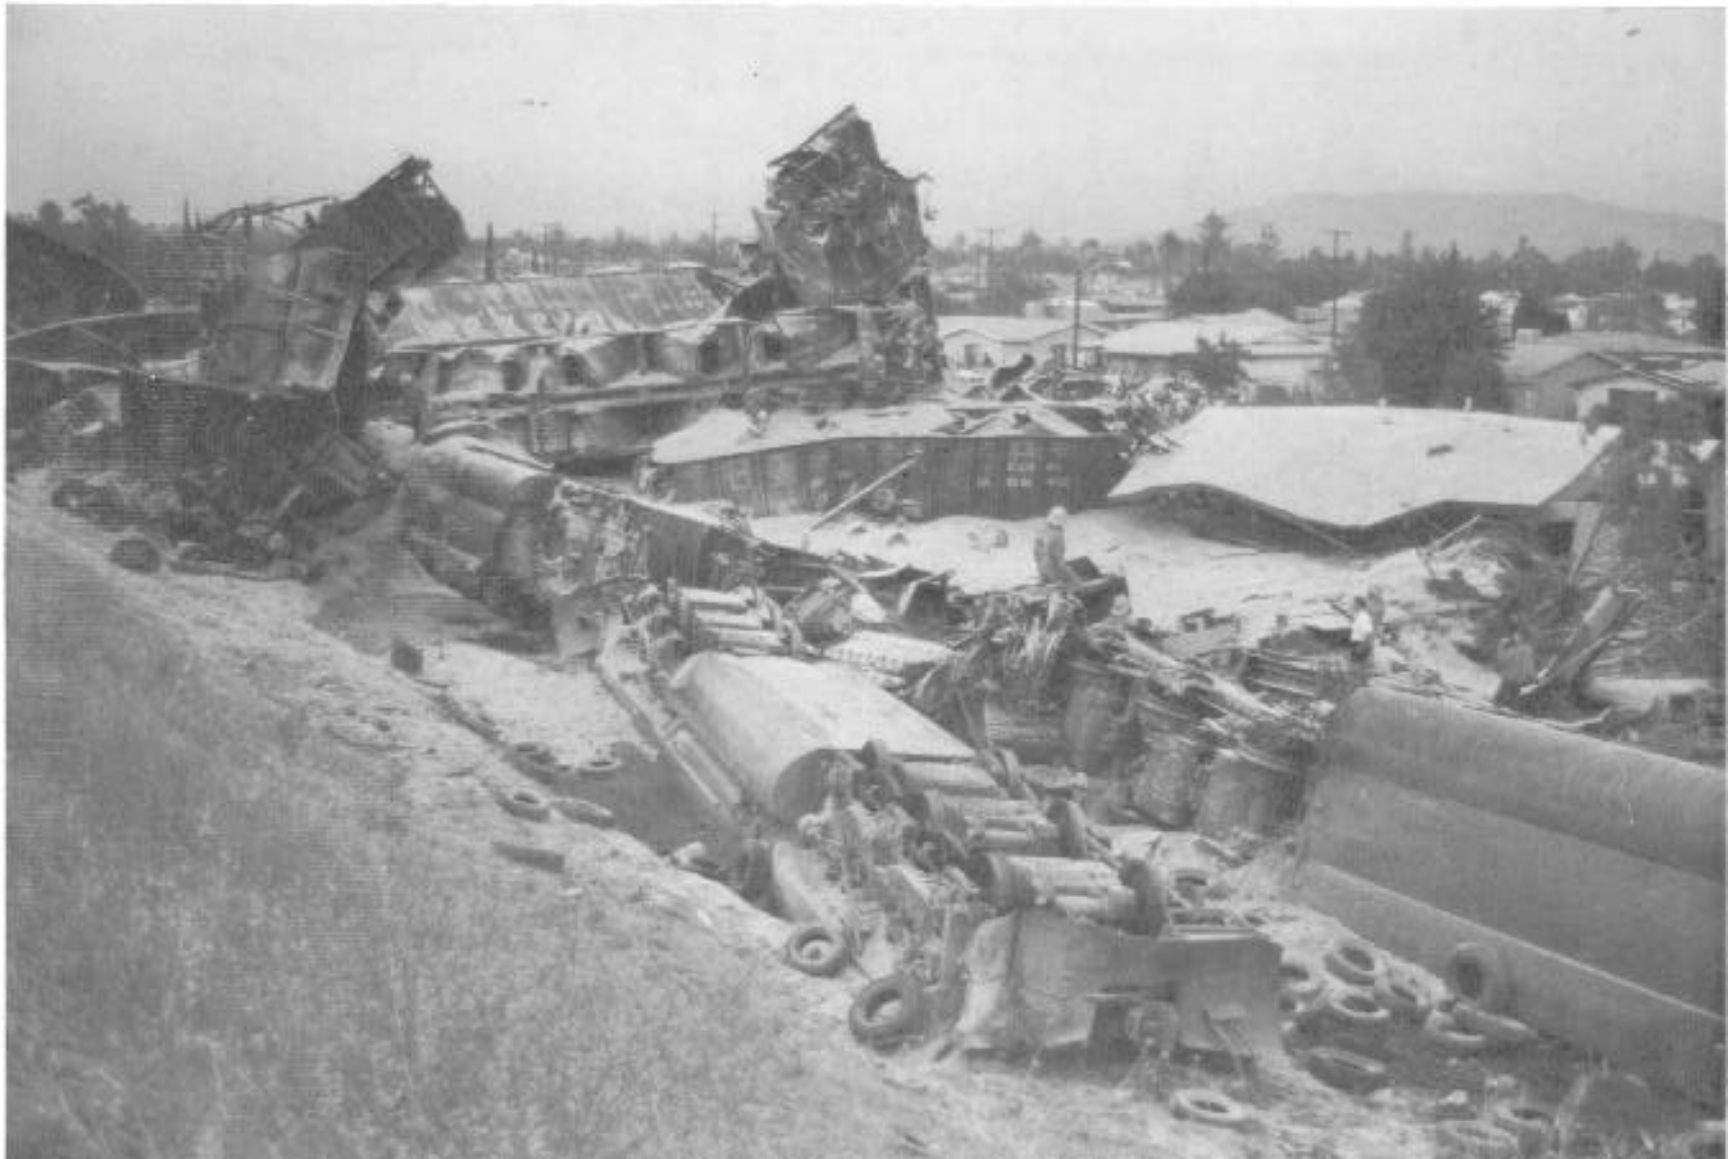
Hopper cars at bottom of embankment in backyards of destroyed houses.

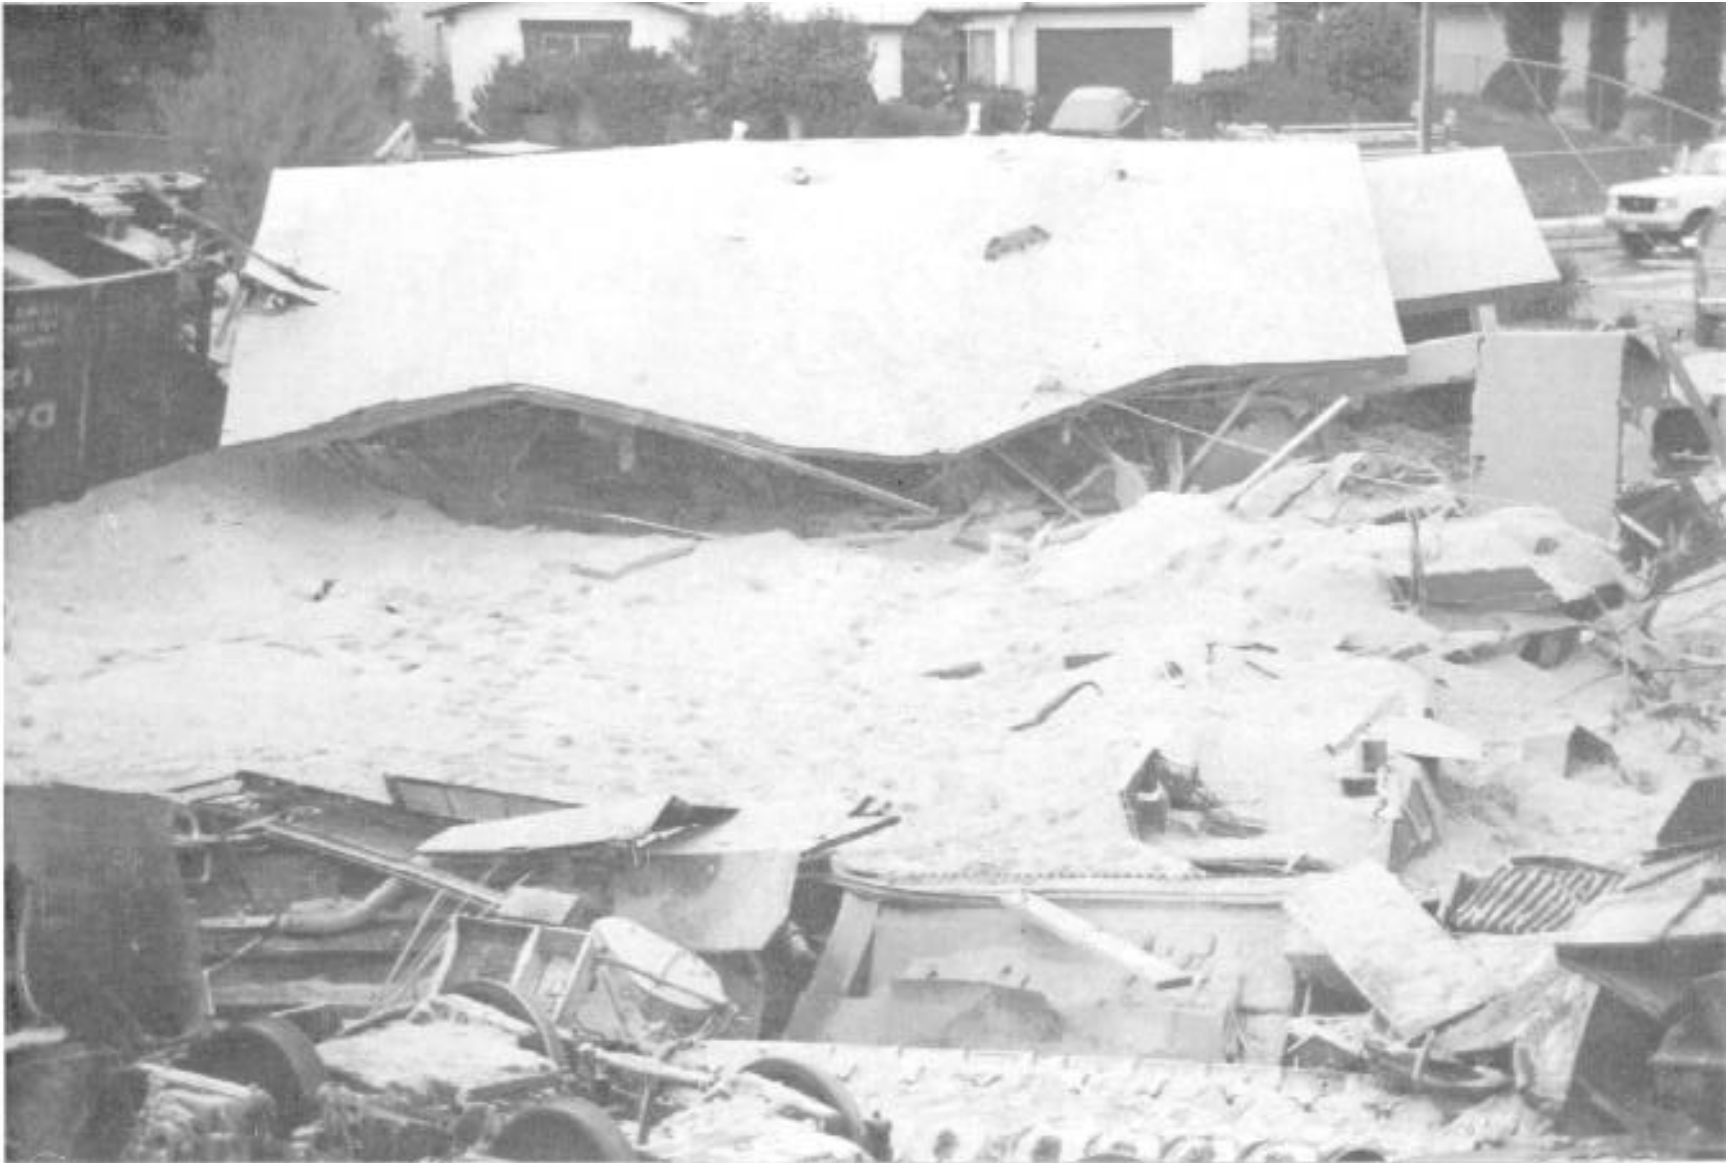
Spilled potash, overturned hopper cars in foreground and at left.

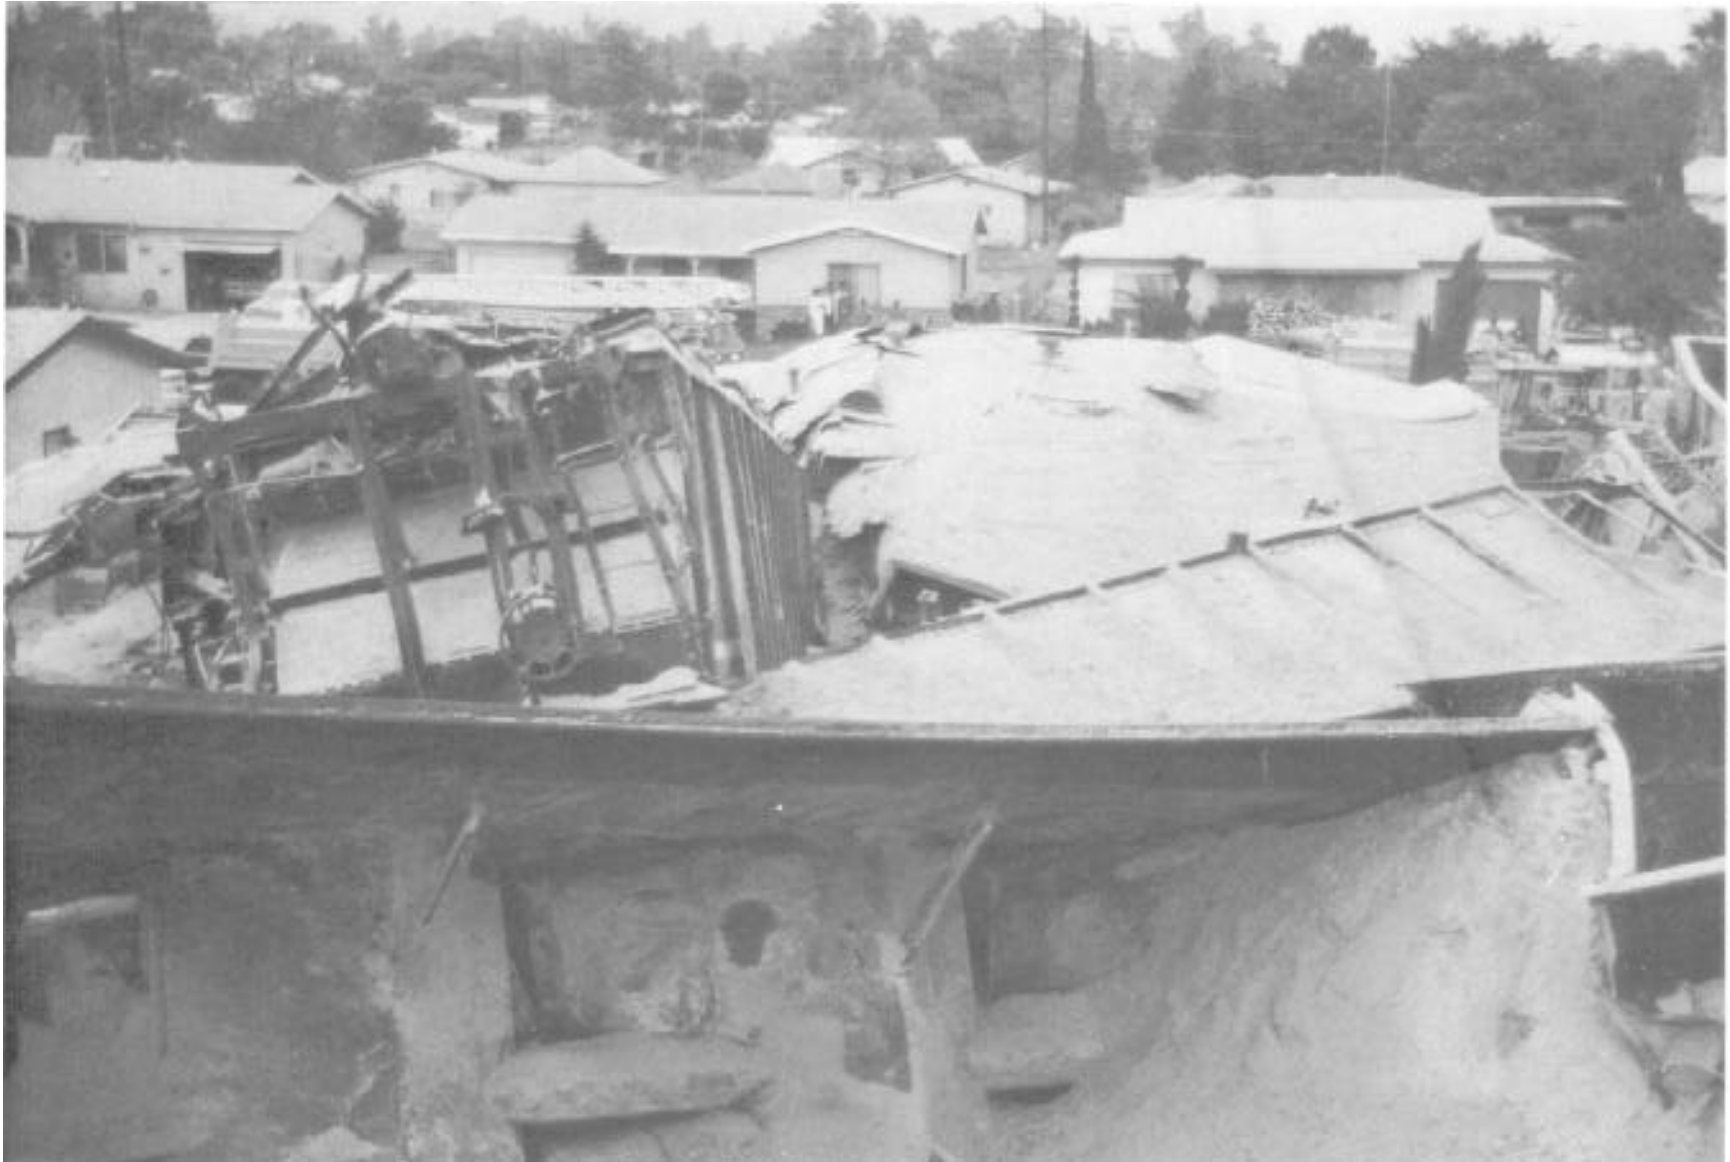
Duffy Street house completely destroyed by overturned hopper cars, remaining roof seen at center of photo.

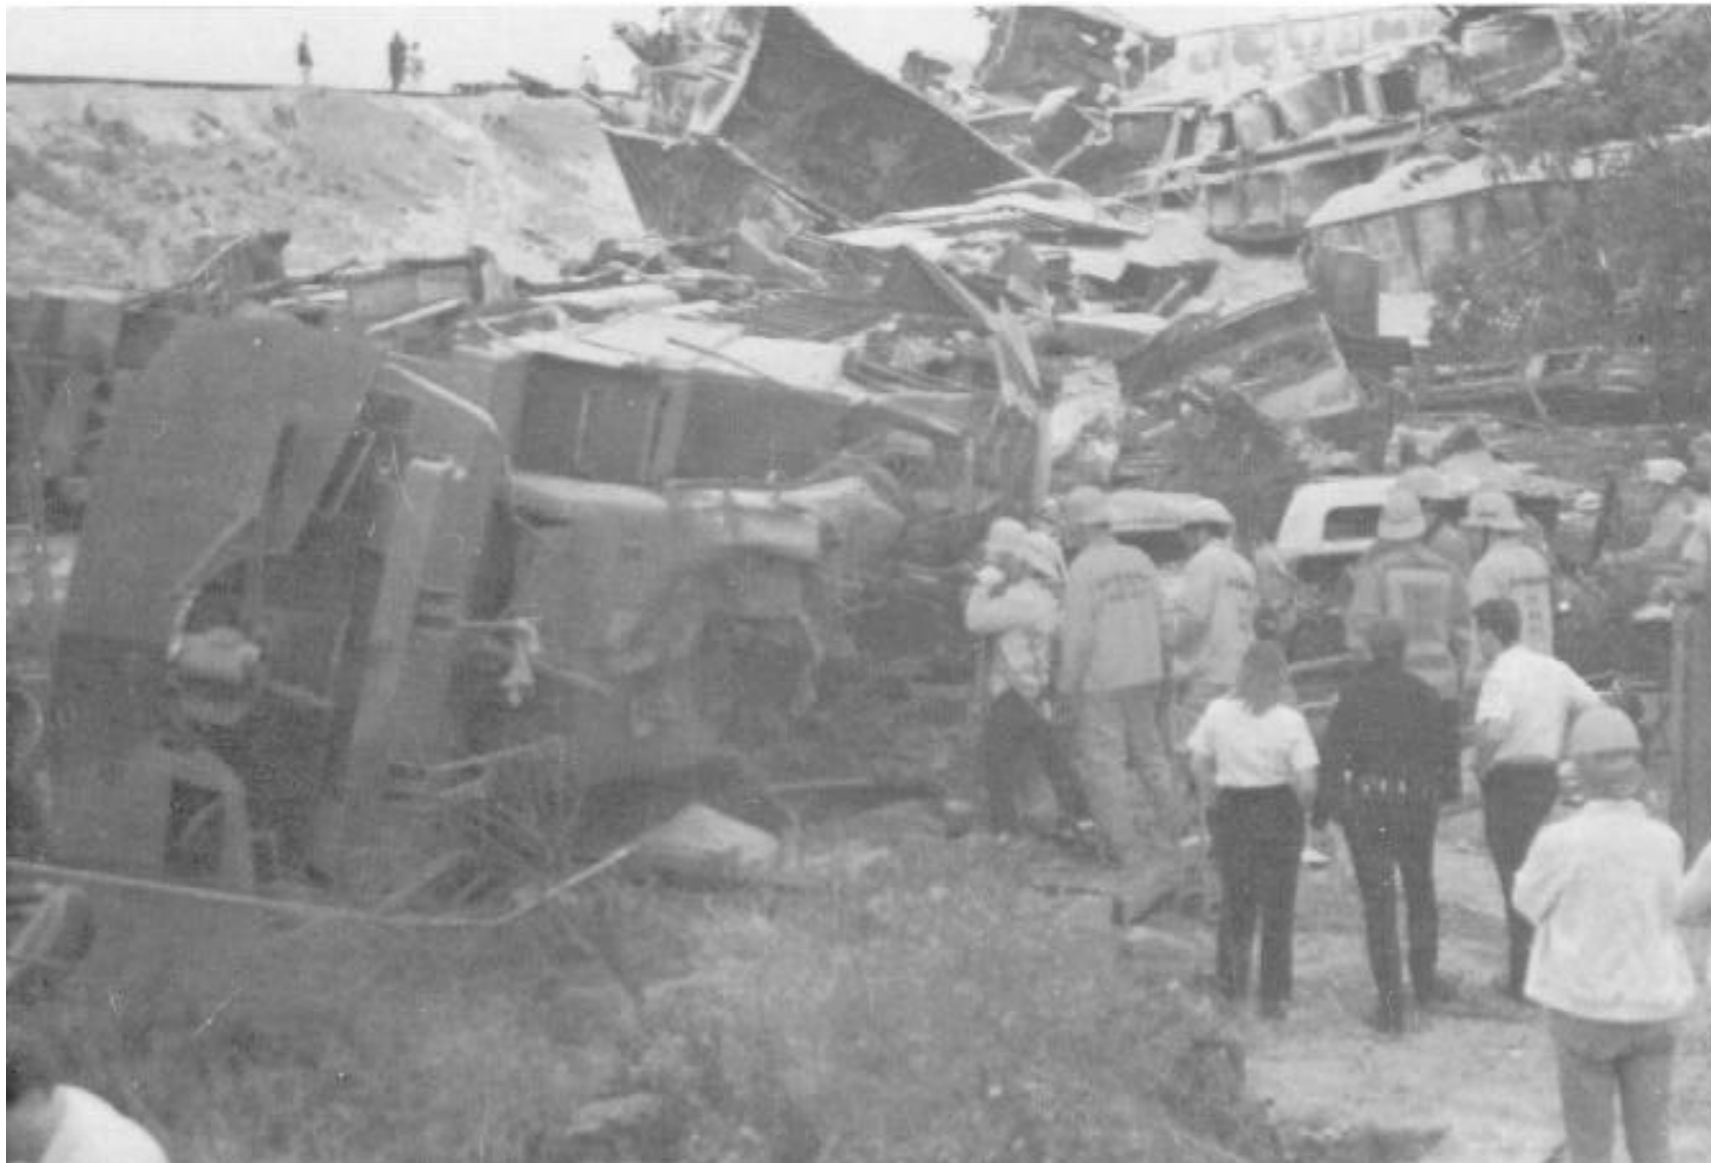
Search and rescue operations underway.

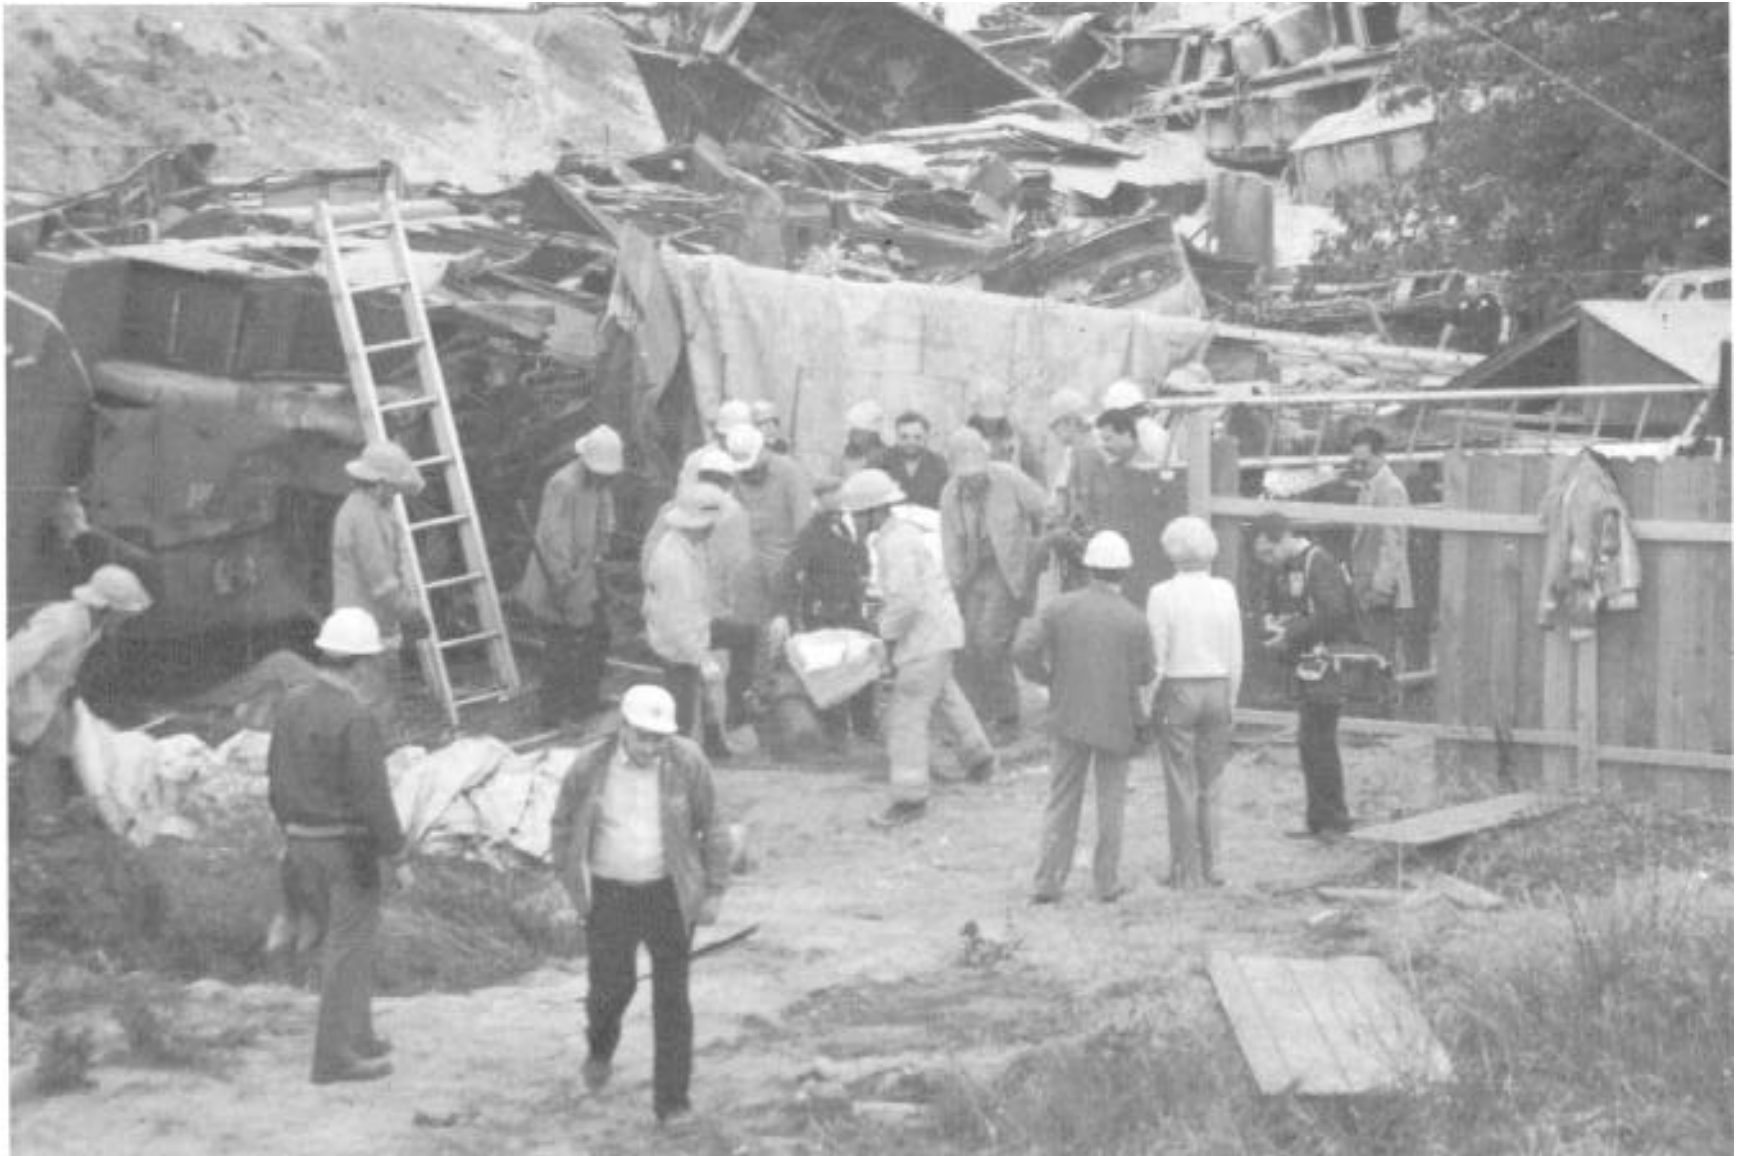
Search and rescue crew remove casualty from crash site.
